FLICKER CAUSED BY OPERATION OF INDUSTRIAL TECHNOLOGY

Martin KASPIREK¹, Petr KREJCI², Pavel SANTARIUS³, Karel PROCHAZKA⁴

¹Management of Grid, E.ON, F. A. Gerstnera 2151/6, 37001 Ceske Budejovice, Czech Republic

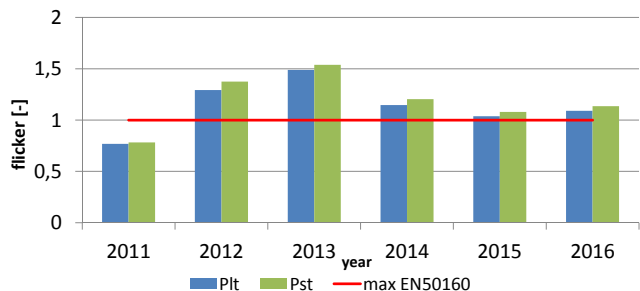
Figure 5 shows the flicker increasing from 2012. The limit $P_{lt}=1$ is exceeded and the problem has to be solved.

Fig. 5: Evaluation of short-term severity (P_{st}) and long-term severity (P_{lt}).

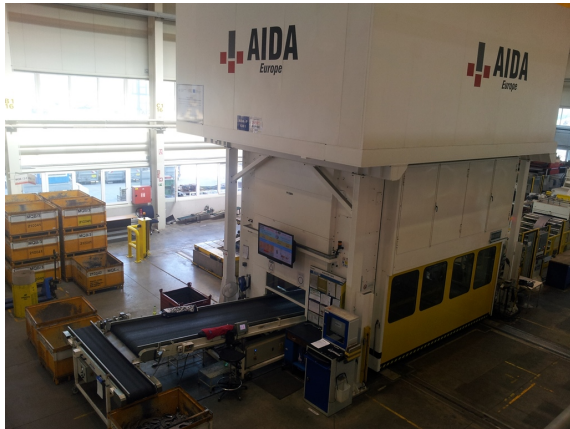
Flicker is produced by the operation of new forging presses (see Fig. 7 and Fig. 8) which were put into operation in 2012.

Fig. 6: Forging press (Magna).

The forging presses operate with a definite reserve for performing the pressing. This reserve was 100 % because of defective work. With the reduction of this reserve the current value should decrease. A decrease in the current value should reduce the flicker level. The customer proposed reducing the reserve R from

R=100 % to R=75 % and R=60 %. The defective work has to be evaluated.

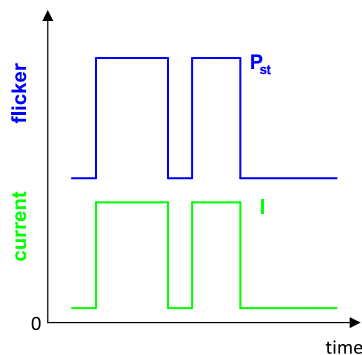
To find the source of flicker it is necessary to measure and evaluate the current and flicker together. When the flicker waveform corresponds to the current waveform (see Fig. 8), the flicker is produced by the customer being measured.

Fig. 8: Dependence of flicker on current.

Magna was informed about the problem of flicker because it was proved that flicker was caused by the customer's operation. The flicker intensity depends on the current intensity – see Fig. 8. The customer did not believe the DNO that the flicker was produced by its operations and so it was decided that the university should perform an independent assessment of the cause of the flicker.

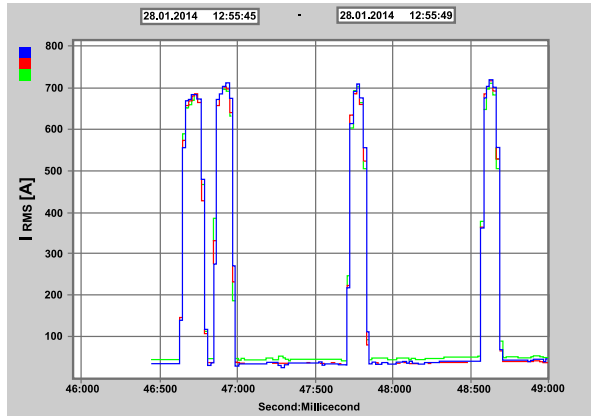
Figure 9 shows that the RMS peak of the current is approximately 700 A if R=100 %. Figure 10 shows that the RMS peak of the current is approximately 540 A if R=75 %. Figure 11 shows that the RMS peak of the current is approximately 400 A if R=60 %. A summary evaluation is given in Tab. 2.

Fig. 9: RMS peak of current, forging press set to R=100 %.

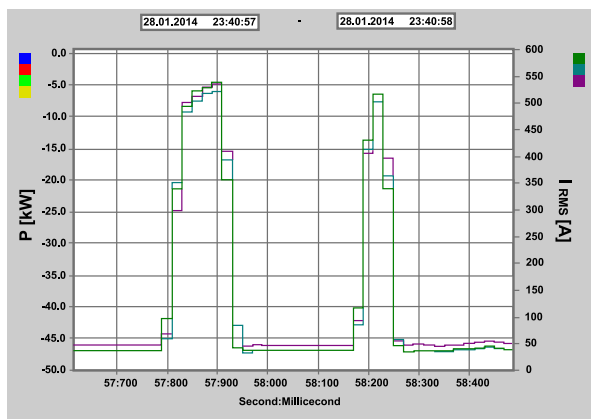
Fig. 10: RMS peak of current, forging press set to R=75 %.

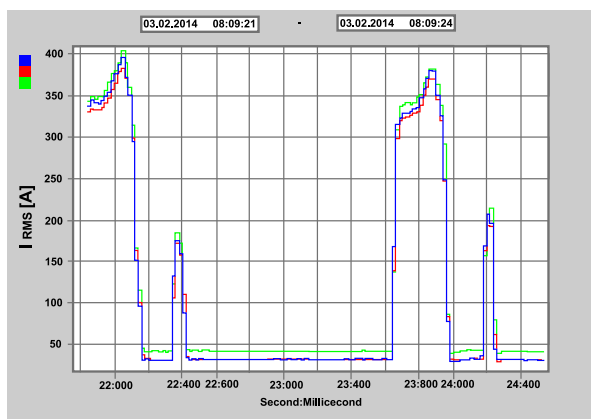
Fig. 11: RMS peak of current, forging press set to R=65 %.

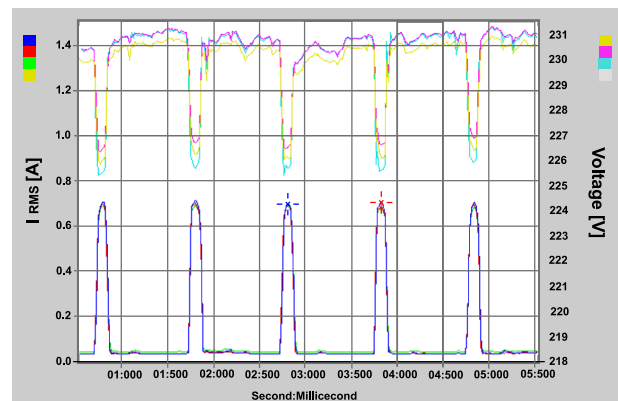
The size of the voltage changes depends on the size of the current peak (see Fig. 12) and the flicker level depends on the size of the voltage changes. Thus the flicker level decreased because of the changes to a lower voltage, but not enough. After the adjustment of both the forging presses to R=60 %, the flicker level reached the value approximately of 1.1 (see Fig. 5, years 2014, 2015 and 2016) and the number of rejects did not increase. The voltage quality in the MV distribution grid does not comply with the requirements of the EN 50160 standard because of flicker but Magna has no other way to solve the problem apart from halting production. Fortunately, no complaints regarding the flicker were received.

Fig. 12: RMS peak of current (lower curve) and voltage changes (upper curve) on the low-voltage level.

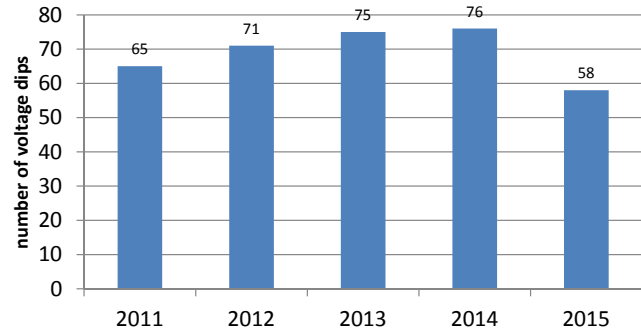
It is interesting that no complaints regarding the flicker were received, although the flicker level exceeds the value $P_{lt}=1$. But complaints about voltage dips were received and one of the complaining customers is Magna. This customer is supplied by a long MV feeder (approximately 30 km) and so many voltage dips occur (see Fig. 14). Voltage dips can cause the same effect as long-term interruption by customers with hard automation. The EN 50160 standard defines no limits for voltage dips but the analysis of historical data can enter the algorithm of the prediction methods used [3]. Voltage dips are typically caused by faults occurring in the public network, so in the case of an outside MV feeder faults and voltage dips mainly occur in summer as a result of the impact of the weather (windstorms). A short voltage interruption on the primary side (on the MV level) results in a short voltage interruption on the secondary side of the MV/LV transformer. Short voltage interruptions of MV feeders with failure are transmitted into other networks as voltage dips [4].

**Fig. 14:** Number of recorded voltage dips at the delivery point of Magna.
