INFLUENCE OF ELECTRIC DISCHARGES ON BEARINGS OF ELECTRIC MACHINES

K. Chmelík, V. Čech, J. Foldyna

VŠB-TU Ostrava, 17.listopadu 15/2172, Ostrava-Poruba, 708 33
e-mail: karel.chmelik@vsb.cz

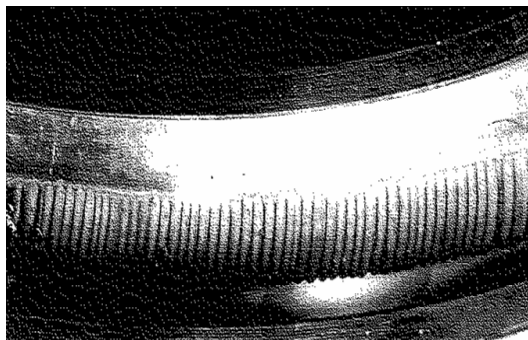
It comes often to bearing failures by electric machines after a short operation time. An example of damaged bearing of electric machine is shown in the fig.1. In general we can say that periodically repeated waves depressions are mostly evident on the surface of rolling ways of bearing rings – fig.1. A surface of rollers or balls has no grooving or other damage recognizable by eye but by enlargement the grooves and craters are clearly visible – fig.2.

Fig.1. The surface of rolling ways of bearing ring

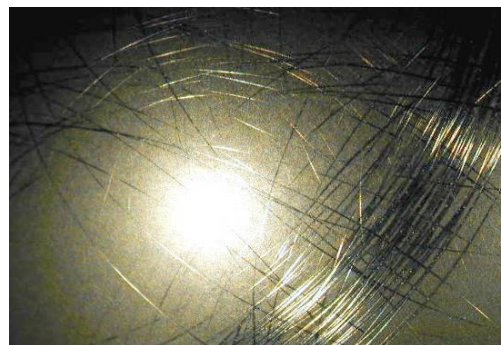
Fig. 2. Surface of ball

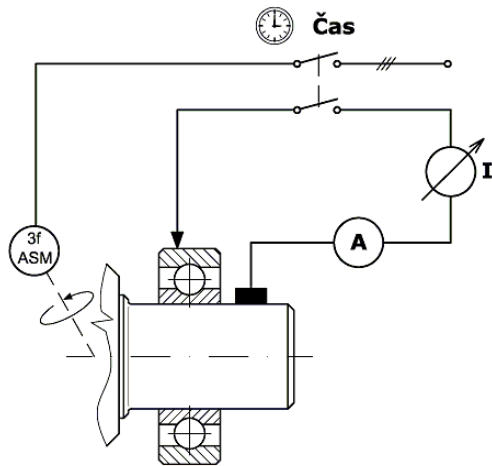
An influence of steady current passage through the tested bearing connected into electric circuit in according with fig.3 was monitored. A current of 1A passed through a bearing during a period of 300 hours. The appearance of inner surface of outer ring after bearing dismantling is shown in the fig.4.

Fig. 3. The testing circuit of bearing

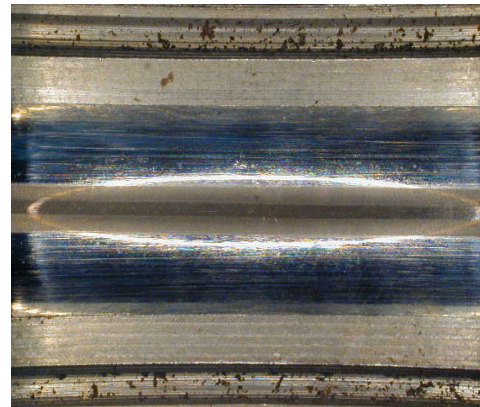
Fig. 4. The damage of ring by current

Different character of bearing damage by steady electric current and current discharges is evident.

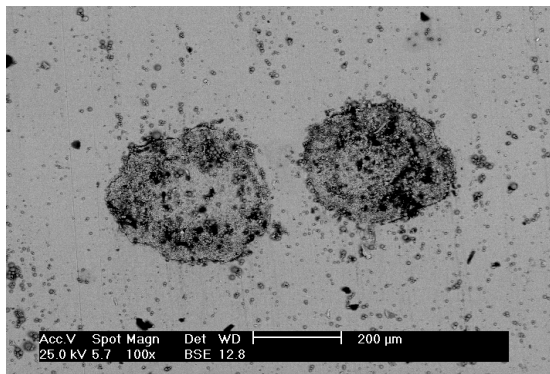
Fig. 5. Disturb of outer ring orbit surface by two testing discharges

Disturb of outer ring orbit surface by two testing discharges is shown in the fig.5 and by enlargement in the fig.6.

Feeding from frequency converter is known as one of the possible cause of bearing current origination. It comes to electric discharges by influence of capacity in the circuit formed by motor, wiring and converter. The electric discharges disturb surface of rings and rolling bodies by penetrating of lubricating layer.

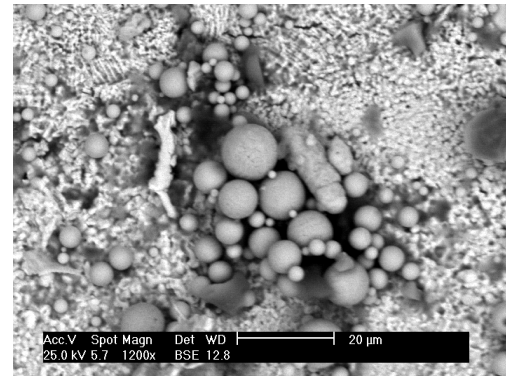
Fig. 6. Disturb of outer ring orbit surface by two testing discharges by enlargement

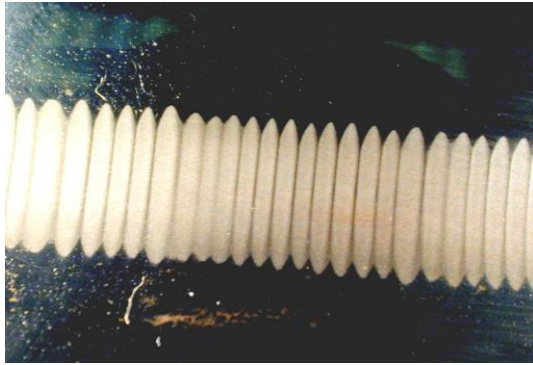
The damage of bearing by grooving is shown in the fig.7. This damage is often marked as influence of bearing currents. Detailed figure (fig.8) indicates on mechanical damage or great concentration of small current pulses which smelted the surface but only to such a degree that due to reduced strength the material could be partially pulled up from the places. The cause of this state could be voltage induced by unbalance due to slotting. Experiments described below were realized for explanation of damaged causes.

Fig. 7. The damage of bearing by grooving

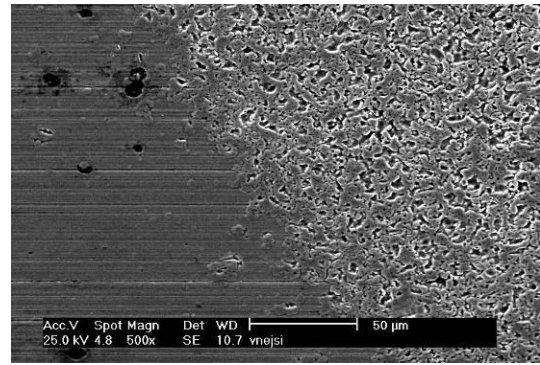
Fig. 8. Detailed figure of damage of bearing by grooving

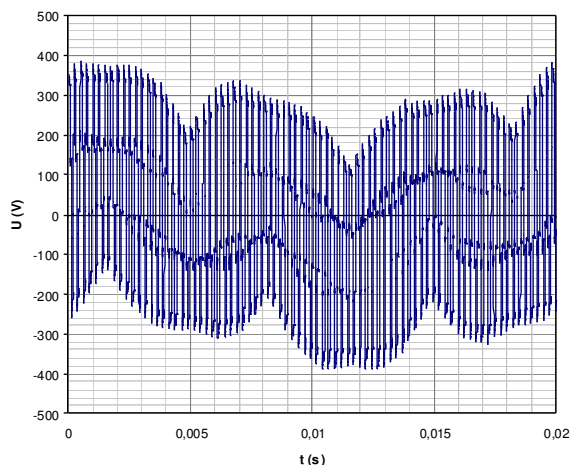
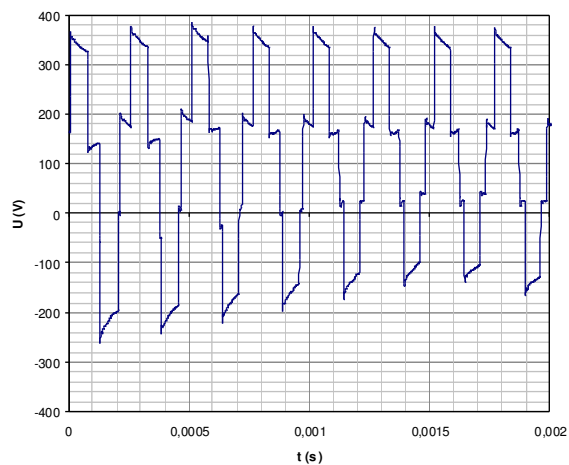
Transient effects originate by feeding of induction motor from frequency converter by switching processes corresponding to RLC circuit parameters. The RLC elements are defined by construction setting of winding at stator packet. Fast time changes of voltage ($10\text{kV}/\mu\text{s}$) applied to winding terminals produce charging and discharging transient effects accompanying the slot insulation polarization. In the case the motor is fed from frequency converter in IT network, an electric potential originates on the motor frame with the course of sum of three voltage courses. The voltage course in our case is shown in the fig.10 by converter adjusting 25Hz of output frequency and 4 kHz of switching frequency.

Fig. 10.a The voltage course on motor frame

Fig. 10.b The voltage course on motor frame

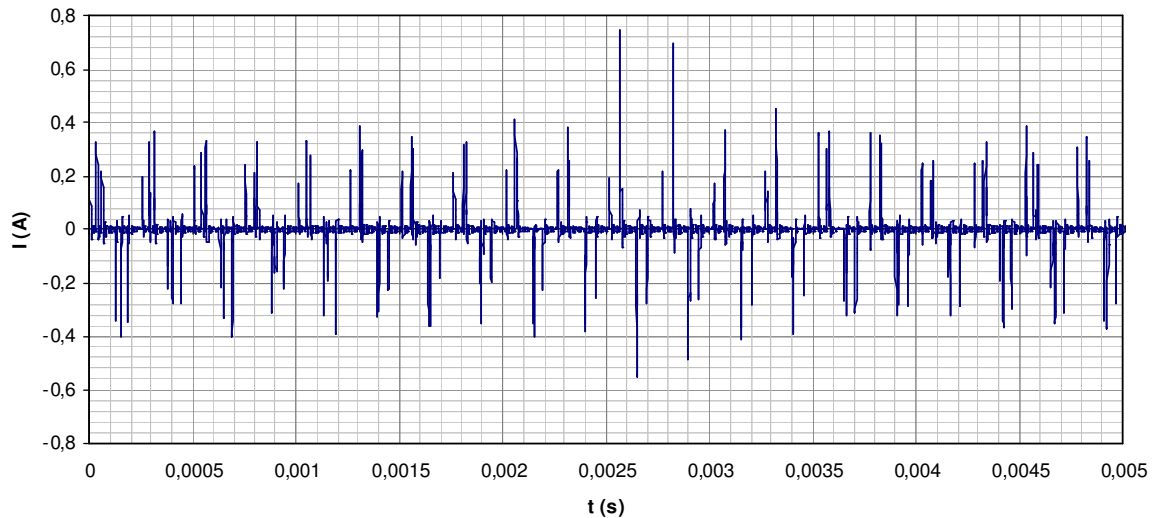
Hybrid bearing had no damage after 100 hours operation with the stress of voltage pulses. When the standard bearing of type 6206ZZ was tested then after 60 hours of operation was damaged and vibration and noise were registered. A course of the current passed through the bearing was measured and is shown in the fig.11.

Fig. 11. Course of the current passed through the bearing

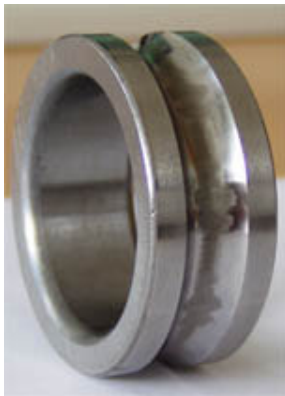
Fig. 12. Damage of inner ring orbit

The damaged bearing was cut and analyzed with result of large damage of outer and inner ring orbits – fig.12. The bearing lubricant was also depreciated.

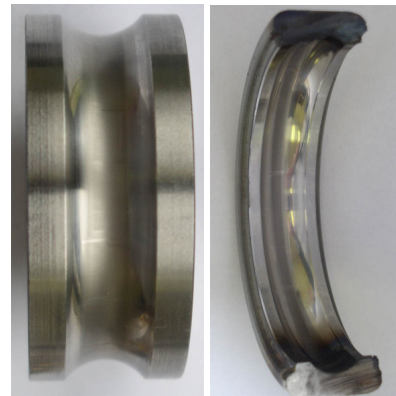
Fig. 13. Damage of insulated bearing after 100 hours of operation

This damage was then confirmed by metallography investigation. A similar damage was observed by insulated bearing after 100 hours of operation (see fig.13). The standard bearing 6206ZZ was then tested without voltage stress for evidence that damage was really created by electric discharges. After 100 operating hours the bearing was analyzed- The surface of outer and inner ring were without damage. At last the test was repeated with the standard bearing and voltage stress. Vibration and noise progressively increase and the bearing was damaged after 100 hours.

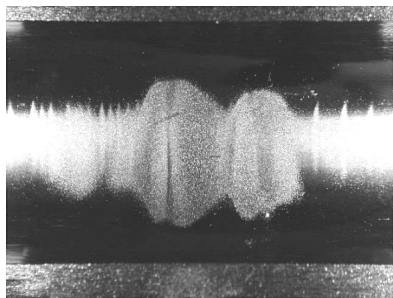
The samples of outer and inner ring, ball and cage were analyzed after bearing cutting. The photography documentation was made for small magnification by stereomicroscope. A matted area was observed by sample of the outer ring in the place of probably contact of the surface with balls. The matted area was about 1/3 of the orbit width. A damage of inner ring sample was also observed. This damage reminded a “rubbing-board” but not so typical. The flutting was appeared on the surface of the sample whereas width and length of bands is different. Areas with periodically different width and length were appeared. Type of damage of inner ring is shown in the fig.14, of the ball in the fig.15 and of the cage in the fig.16. The signs of mechanical damage and plastic deformations of the surface were shown on the cage (fig.16).

Fig. 14. Inner ring 10x

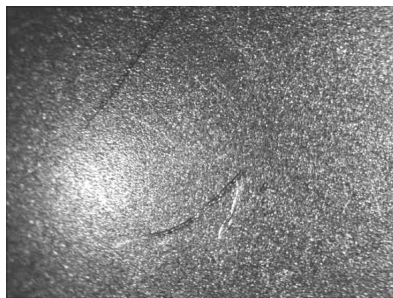
Fig. 15. Ball 45x

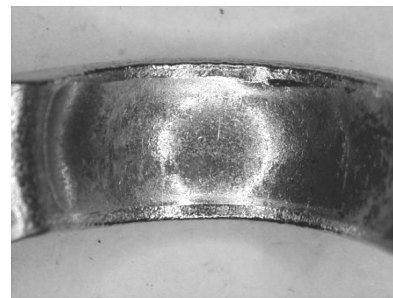
Fig. 16. Cage. 12x

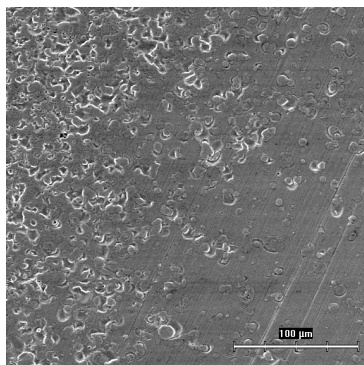
Fig. 17. Outer ring

Detailed analysis of the samples was made by the method scanned electron microscopy. Two different areas were found on the samples of the outer ring. The area with undamaged surface only with small mostly parallel grooves due to tooling and the area of inner ring orbit with crisped surface. It looks to be a thin layer of the new material (fig.17) with noticeable transition between damaged and undamaged part. A similar situation was registered by inner ring too. A layer of new material is stuck in the part of flutting. The undamaged part had only fine grooves given by tooling. An edge of flutting is shown in the fig.18. The rest of grooves are notable on the surface and started to be covered by a layer another material. The ball was crisped on the whole surface with a thin layer of another material(see fig.19).

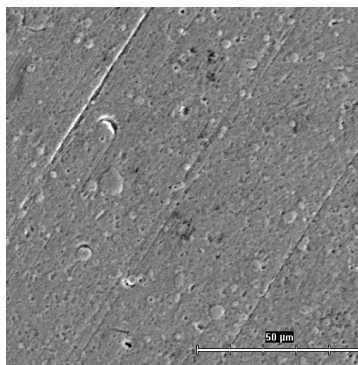
Fig. 18. Inner ring

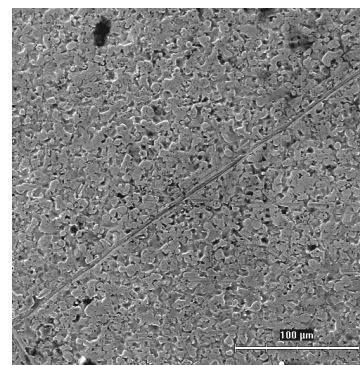
Fig. 19. Ball
