FLICKER CAUSED BY OPERATION OF INDUSTRIAL TECHNOLOGY

Martin KASPIREK¹, Petr KREJCI², Pavel SANTARIUS³, Karel PROCHAZKA⁴

¹Management of Grid, E.ON, F. A. Gerstnera 2151/6, 37001 Ceske Budejovice, Czech Republic

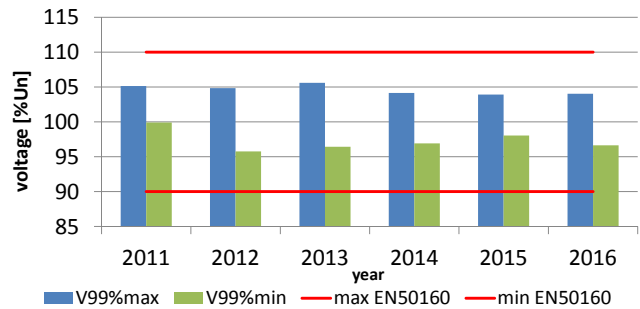
Figure 3 and Fig. 4 show that voltage variations comply with the EN 50160 standard. Small differences between 100 % and 99 % values were evaluated. The maximal 10-min mean values reach the value of 106.7 % U_n (Fig. 4, year 2013) and the minimal values reach the value of 95.8 % U_n (Fig. 4, year 2012).

Fig. 3: Evaluation of voltage variations (99 % percentile).

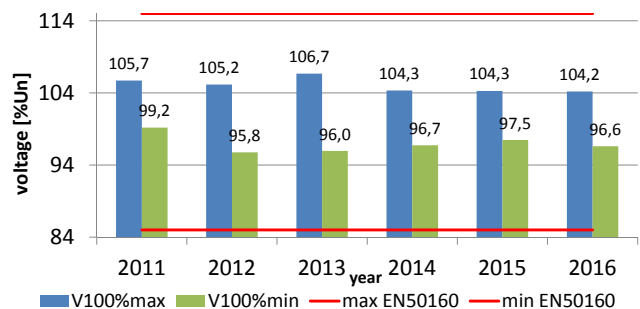
Fig. 4: Evaluation of voltage variations (100 % percentile).

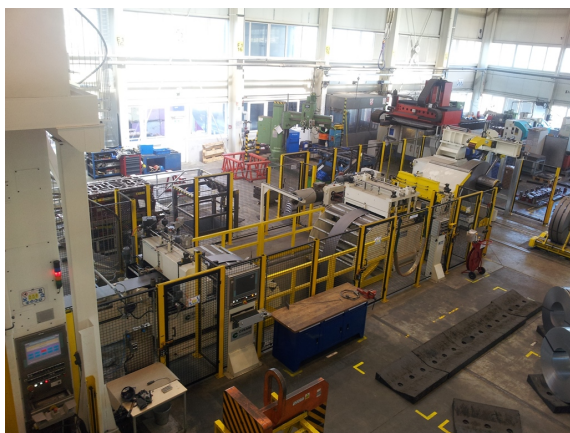
Flicker is produced by the operation of new forging presses (see Fig. 7 and Fig. 8) which were put into operation in 2012.

Fig. 7: Belt feeder of sheet steel for the forging press.

The forging presses operate with a definite reserve for performing the pressing. This reserve was 100 % because of defective work. With the reduction of this reserve the current value should decrease. A decrease in the current value should reduce the flicker level. The customer proposed reducing the reserve R from

R=100 % to R=75 % and R=60 %. The defective work has to be evaluated.

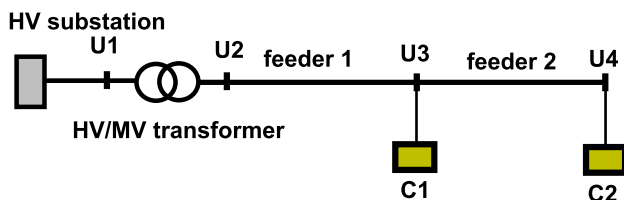
Many other customers are influenced by the operation of the forging presses, or, more precisely, the flicker level $P_{lt}=1$ can be expected to be exceeded at the delivery point of more customers. The highest flicker values should be experienced by customers in the vicinity of Magna. The flicker level should decrease with an increase in the distance from the HV/MV transformer. This theoretical assumption was verified by practical measurement. It was measured at two points of the MV grid. The first measurement was made at the delivery point of Magna (node U4 according to Fig. 13) and the second at the delivery point of another customer (node U3 according to Fig. 13). The distance between the customer C1 and the HV/MV transformer is less than the distance between the customer C2 and the HV/MV transformer. Both the measurements were performed at the same time and the duration of these measurements are one week. The measurements were evaluated according to the EN 50160 standard when the short circuit power was calculated at the delivery points of both the customers.

**Fig. 13:** General circuit diagram of connection of customers to MV grid.**Tab. 4:** Short circuit power and measured values of flicker P_{lt} at the delivery point of the customers.

Customer	S_k'' (-)	Flicker P_{lt} (-)
C1	40.4	0.93
C2	29.2	1.32
